# Breaking the Surface

The cosmetic renovation of a New England building grows to include a significant structural repair.

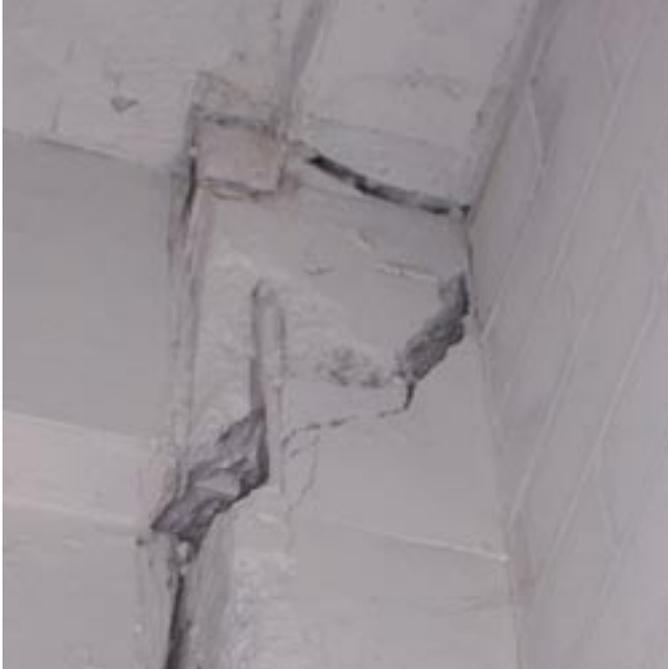
During our initial visit, we noticed a 3-in.-wide crack that extended through the entire cross section of the column. The crack was diagonal, at a 45° angle, at the top of the column approximately 6 in. below the floor and column joint. Settlement, measuring approximately 5 in., was also observed at the corner of the building.

**Above:** The damaged corner column (on the right) is actually at the junction of the main building and an adjacent building.

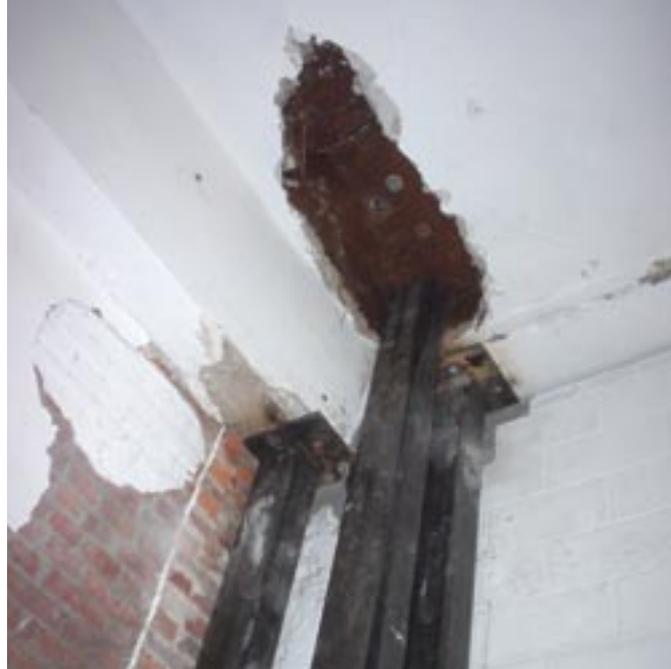
Enlarged view of the corner cracked column. The surrounding structure is covered and could not be observed.

Hollow steel columns, 6 in. by 6 in., now reinforce the damaged concrete corner.

Six-inch-square HSS columns with 12-in. by 12-in. base and cap plates were installed and anchored with 5/8-in.-diameter epoxy anchors. The columns were installed about 24 in. away from the cracked corner column to support the roof corner beams where the concrete was intact, and away from the deteriorated concrete areas.
